WALLKILL RIVER BASIN  
ROCK ISLAND LAKE, SUSSEX COUNTY  
NEW JERSEY

# ROCK ISLAND LAKE DAM NJ 00819

PHASE 1 INSPECTION REPORT  
NATIONAL DAM SAFETY PROGRAM

AUGUST 1981

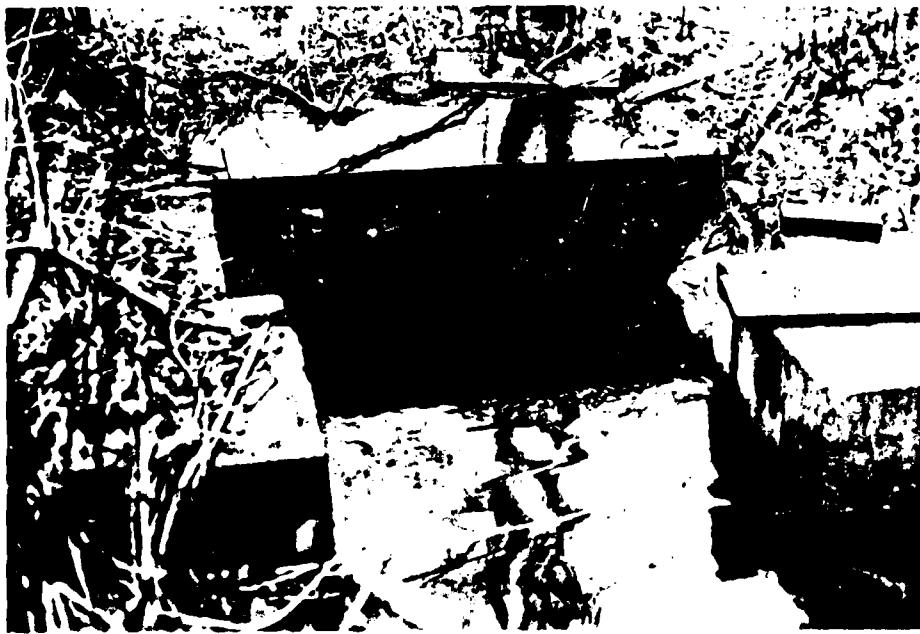
b. Appurtenant Structures. The inlet box leading to the three 12-inch-diameter concrete pipes is clogged with leaves and debris. The concrete of the structure is surface eroded and the mortar in the stone-masonry headwall is missing or cracked. The outlet for these pipes is a 24-inch RCP, located near the downstream toe.

Spillway Intake

(4) Clear inlet box of debris.

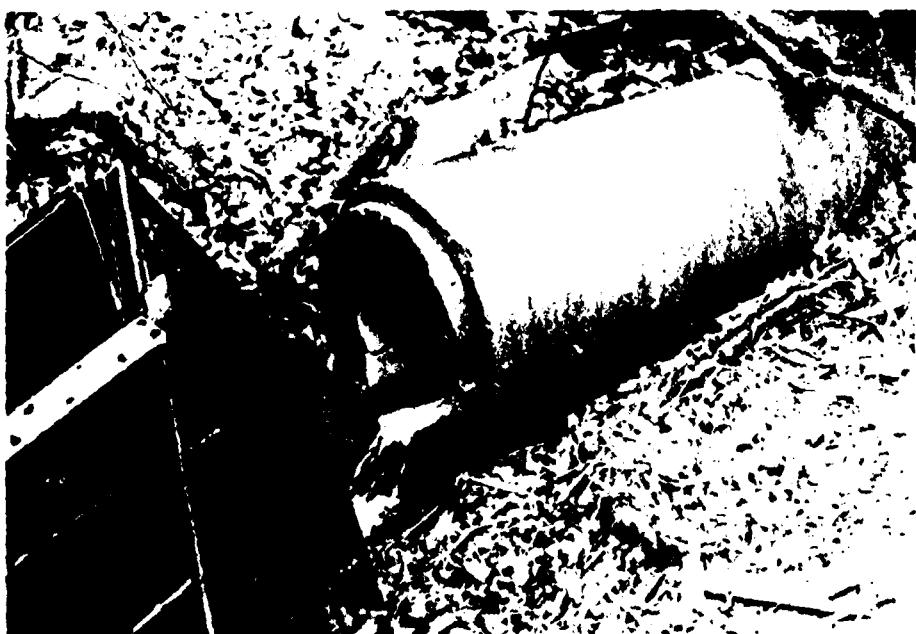
c. Visual Inspection. The inlet box for the spillway pipes contain debris and sediment. The downstream outlet is a 24-inch RCP. At that time, this pipe was discharging a small quantity of whitish-colored, foul-smelling effluent. This may be caused by infiltration through the pipe joints of leachate from dumped material on the downstream face of the dam.

Outlet at center of dam - 24-inch reinforced concrete pipe. Discharging liquid smelling of chemicals. Maybe infiltrating through joints. Ground and rocks around discharge end are discolored and malodorous.

Close-up view of 24-inch RCP spillway outlet pipe

(1) Evaluate the leakage into the spillway discharge pipe and design and oversee corrective measures as required.
